CORRECTED FINAL REPORT

HIGH TEMPERATURE HOT WATER DISTRIBUTION SYSTEM STUDY

**DIRECTORATE OF PUBLIC WORKS
FORT DRUM, NEW YORK**

December 1996

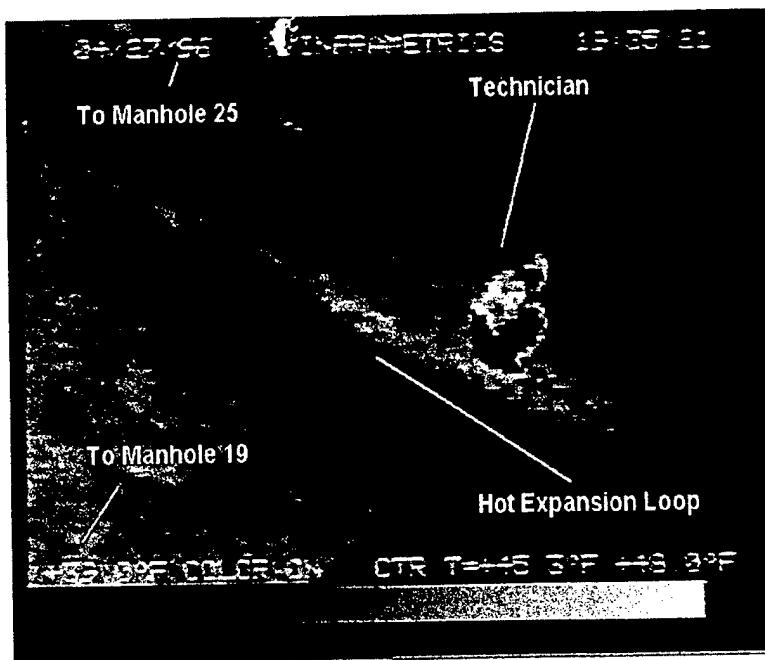
1. Piping from Manhole 19 to Manhole #25 along Second Ave. (16" Sup. Inside a 24" conduit, 16" Ret. Inside a 22" Conduit): The expansion loop area was loosing excessive energy. Two possible causes are: Water in the conduit which has saturated the insulation. Second, the loss of insulation from previous flooding and the action of boiling water. It is not possible to determine if one or both conduits are affected. The balance of the run of pipe appears to be loosing normal levels of energy. The expansion loops may not be laid at the proper angle to allow free flow of the water. This condition will trap water in the expansion loop. The conduit will be subject to corrosion. The insulation may be damaged and boil off the pipe. Recommend excavating the expansion loop and examining the condition of the conduit, pipe and insulation. If the conduit(s) is(are) found to be corroded, the expansion loop(s) can be replaced. Before replacement is considered inspect the conduit for some distance on either side of the "H" legs of the loop to insure the conduit is in weldable condition. The affected sections can be replaced. Once the replacement conduit has been installed an air test will confirm the balance of the conduit is tight.

Manhole #19 to Manhole #25
Expansion Loop on MH #25 side.

Comments: Recommend excavating the expansion loops and examining the condition of the pipe and insulation. Excavate the location along the run of pipe. If the conduit(s) is (are) corroded, the expansion loop can be replaced. before replacement is considered inspect the conduit for some distance on either side of the "H" legs of the loop to insure the conduit(s) is (are) in weldable condition. The affected section(s) can be replaced. Once the replacement conduit has been installed an air test will confirm the balance of the conduit is tight.

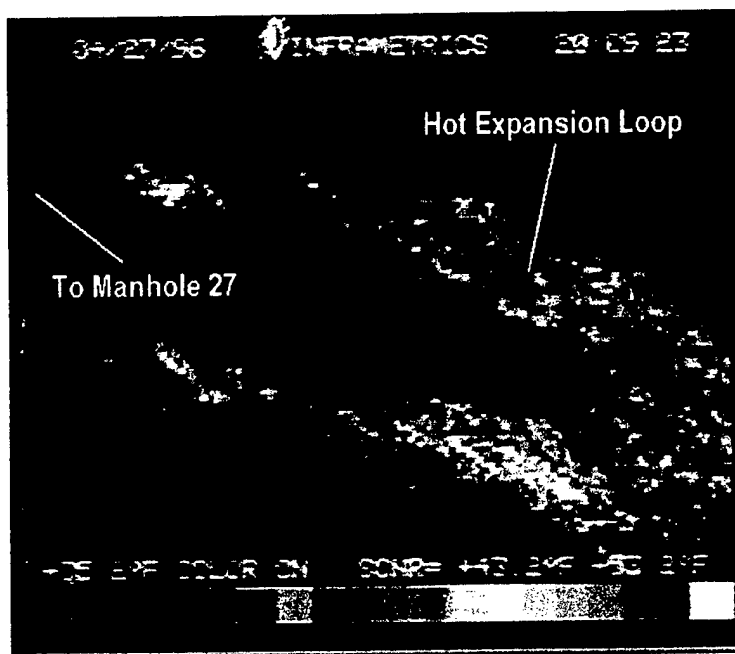
2. Piping from Manhole #26 to Manhole #27 along Second Ave (16" Sup. Inside a 24" conduit, 16" Ret. Inside a 20" Conduit): Two expansion loops and one spot was noted loosing excessive energy. Two possible causes are: Water in the conduit which has saturated the insulation. Second, the loss of insulation from previous flooding and the action of boiling water. It is not possible to determine if one or both conduits are affected. The balance of the run of pipe appears to be loosing normal levels of energy. The expansion loops may not be laid at the proper angle to allow free flow of the water. This condition will trap water in the expansion loop. The conduit will be subject to internal corrosion. The insulation may be damaged and boil off the pipe. Recommend excavating the expansion loops and examining the condition of the pipe and insulation. Excavate the location along the run of pipe. If the conduit(s) is(are) found to be corroded, the expansion loop can be replaced. Before replacement is considered inspect the conduit for some distance on either side of the "H" legs of the loop to insure the conduit(s) is(are) in weldable condition. The affected section(s) can be replaced. Once the replacement conduit has been installed an air test will confirm the balance of the conduit is tight.

Manhole #26 to Manhole #27
Expansion Loop on MH #27 side.

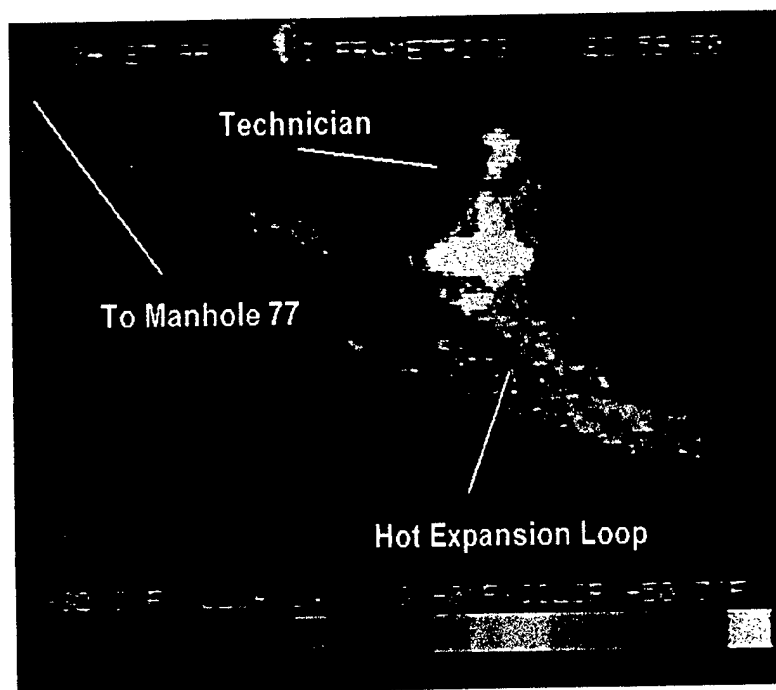
4. Piping from Manhole #77 to Manhole #76 along South Riva Ridge Loop(4" Sup., 4" Ret. Inside an 18" Conduit): The expansion loop area was losing excessive energy. Two possible causes are: Water in the conduit which has saturated the insulation. Second, the loss of insulation from previous flooding and the action of boiling water. It is not possible to determine if one or both conduits are affected. The balance of the run of pipe appears to be losing normal levels of energy. The expansion loops may not be laid at the proper angle to allow free flow of the water. This condition will trap water in the expansion loop. The conduit will be subject to corrosion. The insulation may be damaged and boil off the pipe. Recommend excavating the expansion loop and examining the condition of the conduit, pipe and insulation. If the conduit is found to be corroded, the expansion loop can be replaced. Before replacement is considered inspect the conduit for some distance on either side of the "H" legs of the loop to insure the conduit is in weldable condition. The affected section can be replaced. Once the replacement conduit has been installed an air test will confirm the balance of the conduit is tight.

Manhole #77 to Manhole #76
Expansion Loop on MH #77 side.

Comments: Recommend excavating the expansion loop and examining the condition of the conduit, pipe and insulation. If the conduit is found to be corroded, the expansion loop can be replaced. Before replacement is considered inspect the conduit for some distance on either side of the "H" legs of the loop to insure the conduit is in weldable condition. The affected section can be replaced. Once the replacement conduit has been installed an air test will confirm the balance of the conduit is tight.

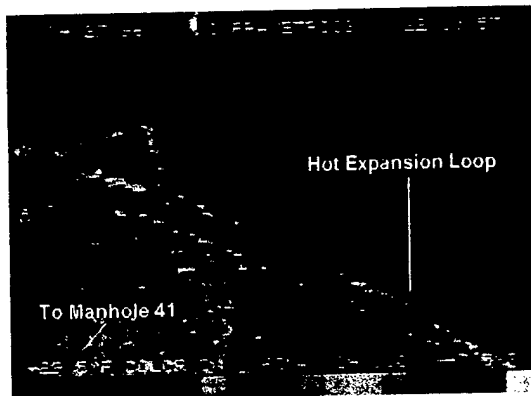
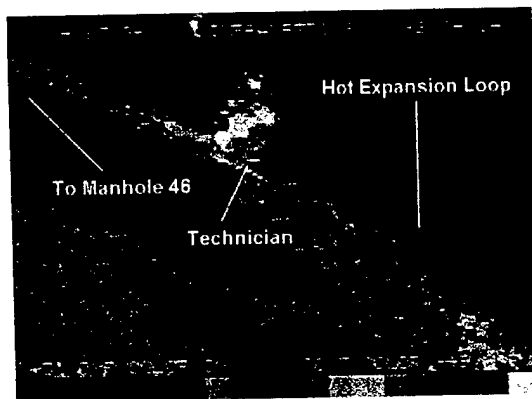
5. Piping from Manhole #41 to Manhole #46 along Fourth Street.(8" Sup. Inside a 16" conduit, 8" Ret. Inside a 14" Conduit): Three expansion loops were noted losing excessive energy. Two possible causes are: Water in the conduit has saturated the insulation. Second is the loss of insulation from previous flooding and the action of boiling water. It is not possible to determine if one or both conduits are affected. The balance of the run of pipe appears to be losing normal levels of energy. Recommend a tracer gas survey to determine the extent of damage to the conduit. The ends of the conduit inside the manholes may be corroded allowing water from flooded manholes to back-up into the conduit. The expansion loops may not be laid at the proper angle to allow free flow of the water. The water will stand in the expansion loops. The conduit will be subject to corrosion. The insulation may be damaged and boil off the pipe. The pipe may be protected from external corrosion from the operating temperature of the HTHW system. If the tracer gas survey determines the conduit is corroded for the majority of its length the piping should be replaced. Once corrosion has progressed along a run of conduit for the majority of its length it becomes impossible to predict remaining service life.

If the conduit ends inside Manhole #41 and Manhole #46 are corroded beyond repair it will not be possible to test the conduit using a tracer gas. The expansion loops can be excavated and inspected. If the conduit(s) is(are) found to be corroded, the expansion loops can be replaced. Before replacement is considered inspect the conduit for some distance on either side of the "H" legs of the loop to insure the conduit is in weldable condition. The affected section(s) can be replaced. Second step is to excavate around the manholes and determine the condition of the conduit entries. It may be possible to replace the entry pieces and the expansion loops. This will allow an air test to insure the balance of the conduit is tight.

Manhole #41 to Manhole #46
Expansion Loop on MH #41 side.

Center Loop

Expansion Loop on MH #46 side.

Comments: Recommend a tracer gas survey to determine the extent of damage to the conduit. The ends of the conduit inside the manholes may be corroded allowing water from flooded manholes to back-up into the conduit. The expansion loops may not be laid at the proper angle to allow free flow of the water. The water will stand in the expansion loops. The conduit will be subject to corrosion. The insulation may be damaged and boil off the pipe. The pipe may be protected from external corrosion from the operating temperature of the HTHW system. If the tracer gas survey determines the conduit is corroded for the majority of its length the piping should be replaced.

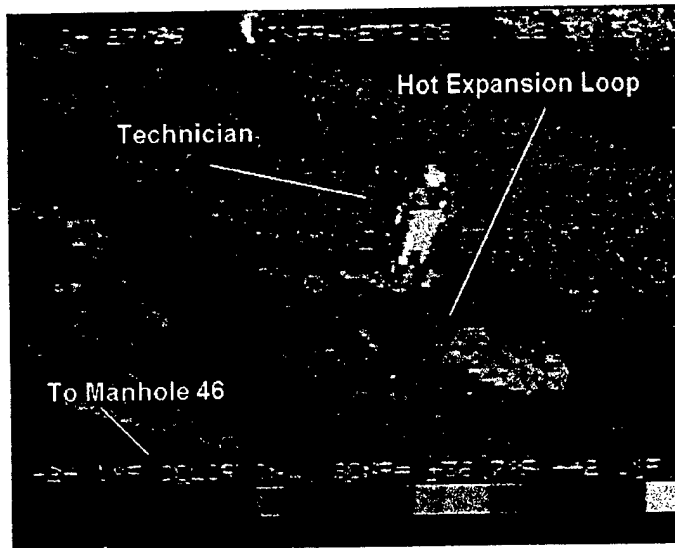
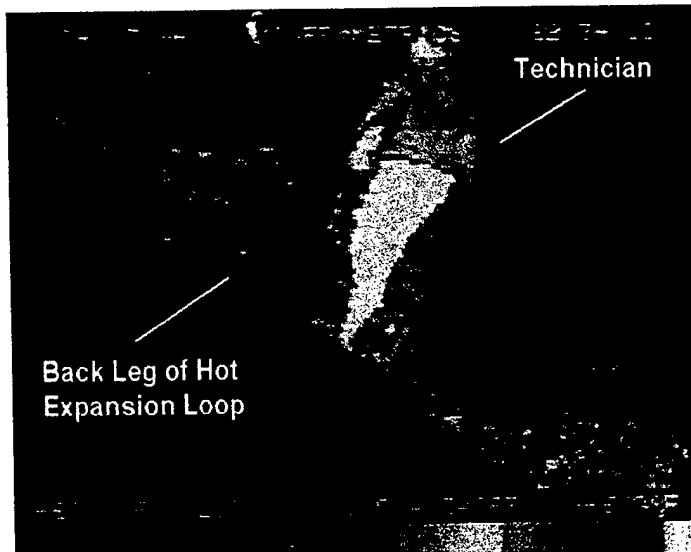
6. Piping from Manhole #46 to Manhole #47 along Fourth Street.(8" Sup. Inside a 16" conduit, 8" Ret. Inside a 14" Conduit): Two expansion loops were noted losing excessive energy. This problem may have its origin in Manhole #46. The conduit ends may be corroded allowing water from flooding to enter the conduits. The expansion loops may not be laid at the proper angle to allow free flow of the water. The water will stand in the expansion loops. The conduit will be subject to corrosion. The insulation may be damaged and boil off the pipe. Recommend excavating the expansion loops and examining the condition of the conduit, pipe and insulation. If the conduit is found to be corroded, the expansion loop can be replaced. Before replacement is considered inspect the conduit for some distance on either side of the "H" legs of the loop to insure the conduit is in weldable condition. The affected section can be replaced. Once the replacement conduit has been installed an air test will confirm the balance of the conduit is tight.

Manhole #46 to Manhole #47
Expansion Loop on MH #46 side.

Manhole #46 to Manhole #47
Expansion Loop on MH #47 side.

Comments: Recommend excavation the expansion loops and examining the condition of the conduit, pipe and insulation. If the conduit is found to be corroded, the expansion loop can be replaced. Before replacement is considered, inspect the conduit for some distance of either side of the "H" legs of the loop to insure the conduit is in weldable condition. The affected section can be replaced. Once the replacement conduit has been installed an air test will confirm the balance of the conduit is tight.

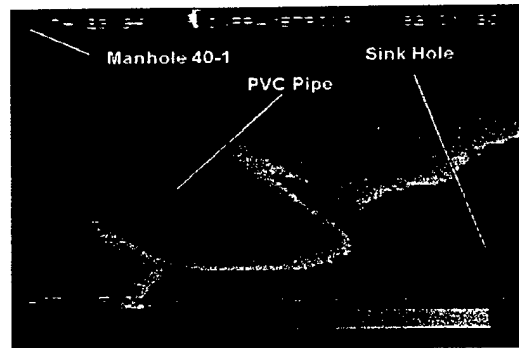
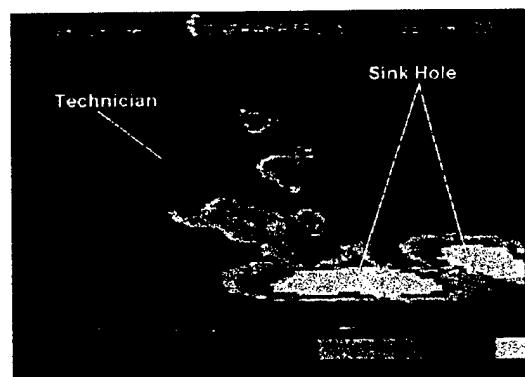
7. Piping from Manhole #40-1 to Manhole #40-2 to Building 1051.(1.5" Sup., 1.5" Ret. Inside a 12" Conduit): The piping between Manhole 40-1 and Manhole 40-2 should be replaced. The condition appears to be beyond economic repair.

Manhole #40-1 to Manhole #40-2
Image #1, Sink Hole

Manhole #40-1 to Manhole #40-2
Image #2, Sink Hole

Manhole #40-1 to Manhole #40-2
Image #3, second sink hole
